A METHODOLOGICAL APPROACH TO THE SAFEGUARD OF THE WOODEN DOOR OF TODI CATHEDRAL

Giorgia Genco, Claudia Maura, Angela Lo Monaco, Maurizio Marabelli, Claudia Pelosi
Tuscia University, Viterbo, Italy
Correspondence to: genco@unitus.it

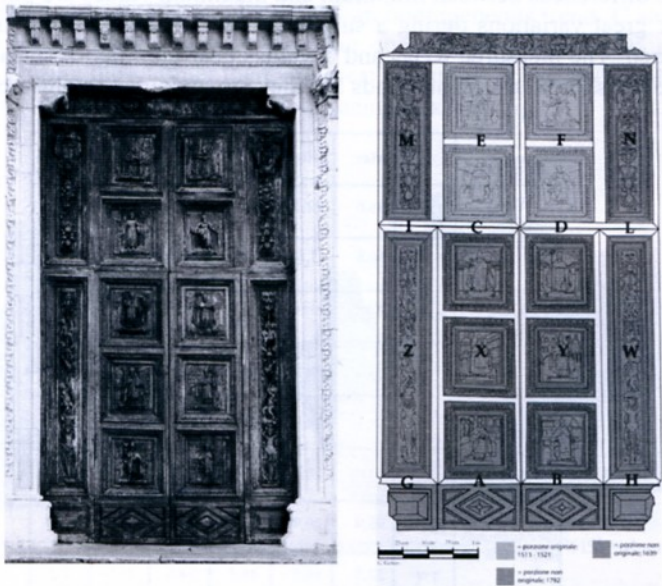
The wooden door of Todi Cathedral was realized in 1521 by the master Antonio Bencivegna da Mercatello da Massa (fig. 1a). In 1623 it was seriously damaged by a lightning, so some years later, in 1639, the door was partly reconstructed by the artist Carlo Lorenti. Instead the plinth was reconstructed in 1792 (fig. 1b).

Figure 1 Outside surface of the door and mapping of the historical manufactured phases.

Afterwards the door underwent several restoration interventions; the last one was carried out between 1998 and 1999. Nowadays the state of conservation of the door is seriously compromised because of both the last incorrect restoration interventions and the position that the wooden door takes up in the Cathedral façade. The deterioration of the surface above all was caused by the variations of temperature and relative humidity (RH%) and it is different in the various parts of the door. In fact, the inner surface shows a less deterioration due to both the more stable environmental conditions and the plain manufacturing typology.

The investigations carried out on the wooder door of Todi's Cathedral showed a very critical situation due to chemical and physical processes but also to the lack of a correct both ordinary and planned maintenance. The use of protectives on the door surfaces doesn't guarantee a long preservation from the environmental conditions especially if this operation is not followed by a valid planned maintenance. Nowadays the door of Todi requires an urgent restoration intervention that should include the cleaning of the surfaces and the structural consolidation. Nevertheless the true solution for the safeguard of the door is probably its urgent removal and its conservation inside the church, in controlled conditions.

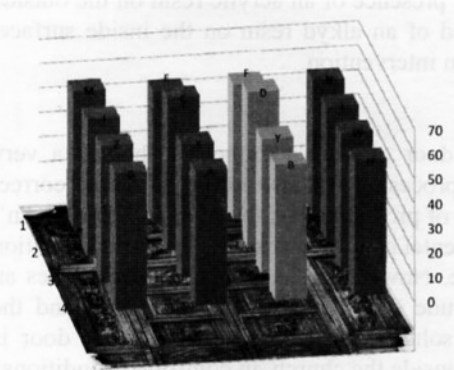
The winter outside and inside air RH% values show an homogeneous trend. C and D points have different RH% values compared with the other ones, in particular 62,5% and 62,8% respectively (fig. 4). During the summer there are great variations of the RH% values due to the influence of solar radiation that affect the door facing to south (fig. 5).

Figure 4 Average winter outdoor RH% values

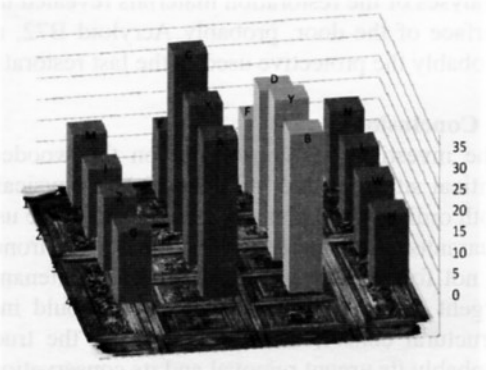
Figure 5 Average summer outdoor RH% values

These considerable fluctuations give rise to unremitting movements of the wood because of the absorption and desorption of water vapour. The RH% values show great variations also between the different areas of the door: they range from 16,3% to 18,1% as regards the fixed panels, whereas they range from 32,3% to 41,9% as regards the shutters that can be

opened. This lack of air hygrometric equilibrium near the outside surface of the door may be considered the main cause of deterioration of the wooden matter.

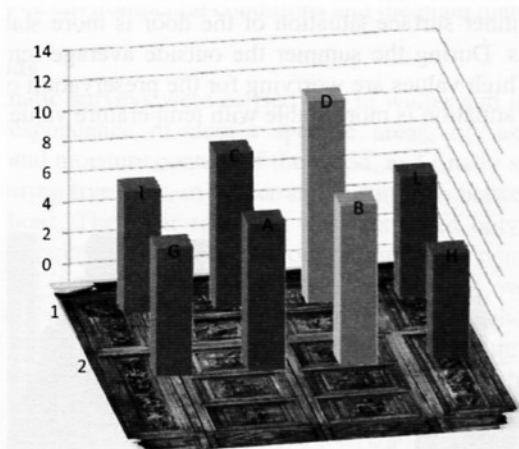
The wood outside surface humidity values keep under 12% (this is considered an optimum value for the preservation of wooden works of art) and they lower to 6% during the summer (fig. 6).

Figure 5 Average winter outdoor wood surface humidity values (%).
