# Multi-Technique Approach by Traditional and Innovative Methodologies to Support the Restoration of a Wall Painting from the 16th Century at Palazzo Gallo in Bagnaia, Viterbo, Central Italy

**Abstract:** This paper summarizes the main results of the study, diagnostics, and restorations conducted and applied to a 16th century wall painting (a portion of the frieze and the Riario coat of arm) in Palazzo Gallo (Bagnaia, Viterbo district—central Italy) recently concluded, which was also the subject of a master's degree thesis in Conservation and Restoration of Cultural Heritage at the University of Tuscia, Viterbo. Innovative imaging techniques were used for the first time on a wall painting on-site: hypercolorimetric multispectral imaging (HMI) and pulse-compression thermography (PuCT), combined with more traditional analysis such as X-ray fluorescence spectroscopy, Fourier transform infrared spectroscopy, and cross-section investigation. HMI allowed for mapping the conservation status before and after the removal of the *scialbo* layer that covered the original paintings. It also allowed different areas of the painting to be compared and for verifying the effectiveness of the clean

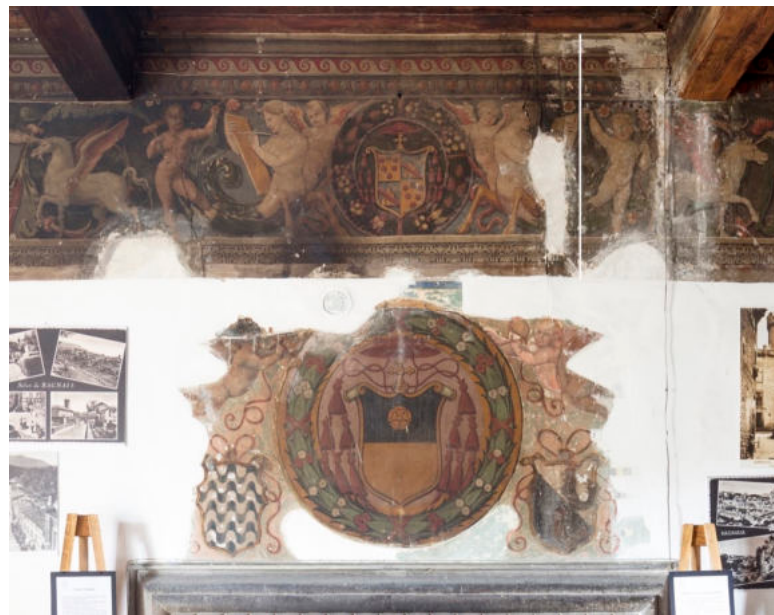
**Figure 1.** The wall paintings before the restoration (photograph by Gaetano Alfano).

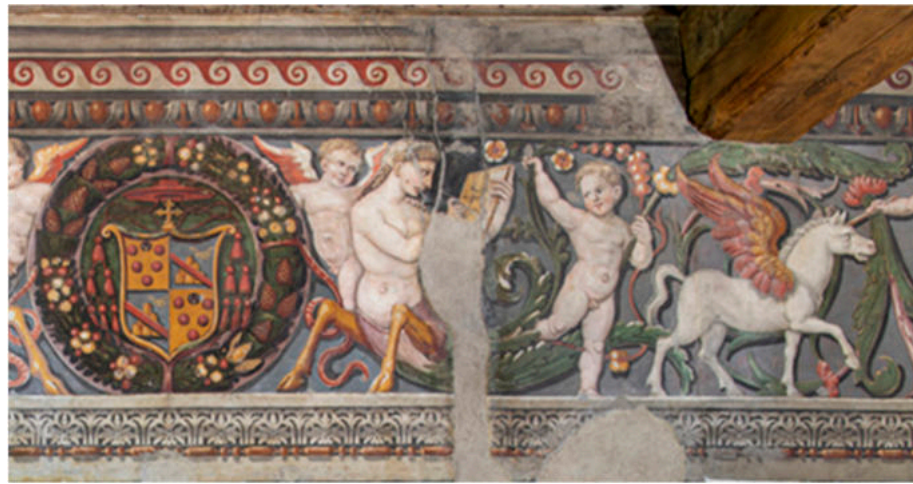
**Figure 3.** Detail of the frieze decoration on the south wall after restoration, original painting.

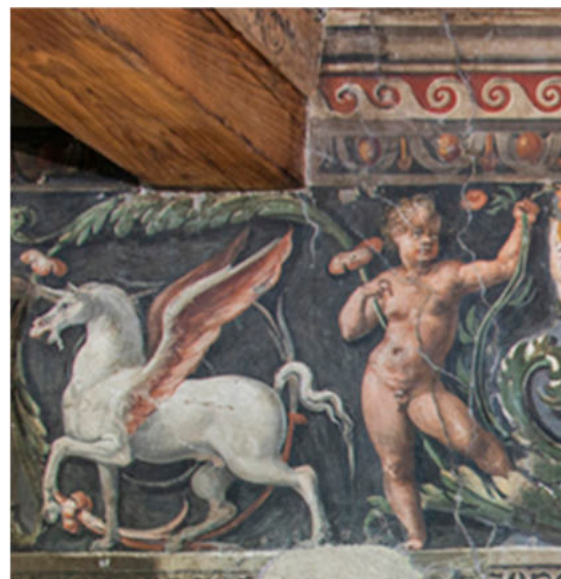
**Figure 4.** Detail of the ancient restoration after the present intervention.

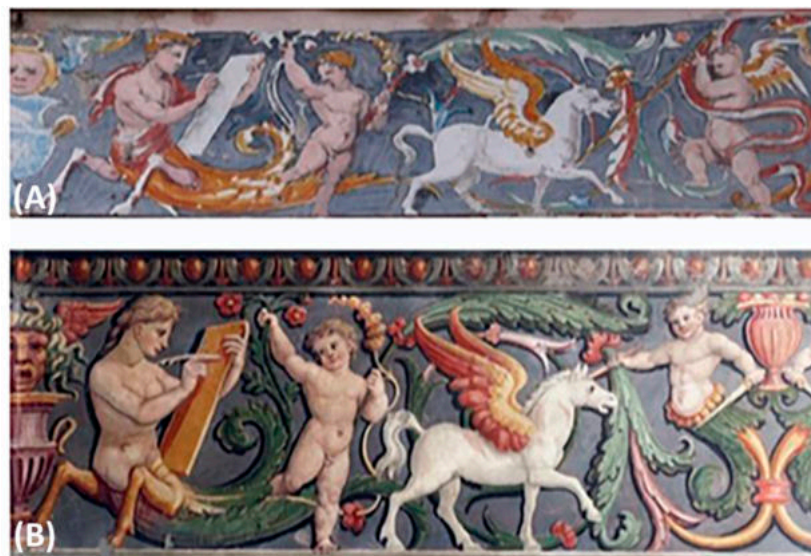
**Figure 5.** Frieze in the church of S. Maria della Fortezze (Viterbo) (A) compared with that of the Sala Riario of Palazzo Gallo (B).

The frieze of S. Maria delle Fortezze shows an iconographic composition very close to that of Bagnaia room. Except for a few details, the figure of the putto is central and can also be found slavishly in another panel of the church's paintings. Some differences can be noticed in both the sizes and orientation of the figures. Consequently, a very similar executive technique is deduced, in particular concerning the use of cardboard and on the way the pictorial layers are drafted, using very similar colors.

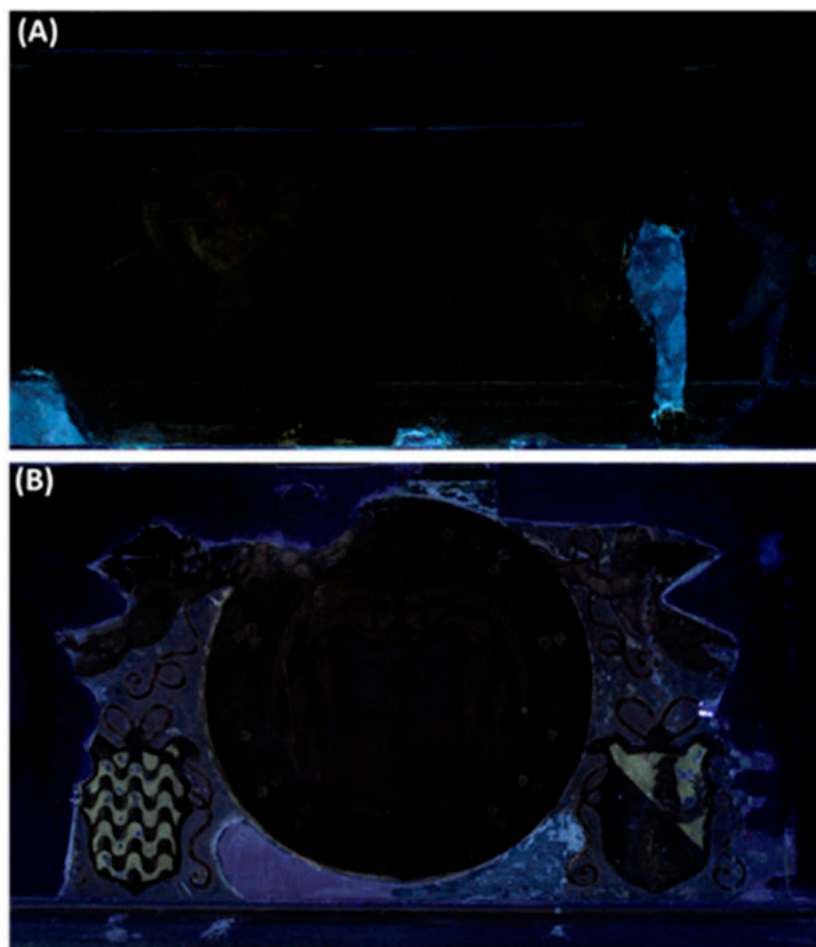
The first relevant result was obtained with the UVF acquisition performed before the painting cleaning. In fact, UVF images give fundamental information about the conservation state of the painting surfaces, on the presence of retouched areas and grouting, etc. [13]. By observing the UVF images of the two paintings, the first evidence is related to an intense yellow response in the coat of arms of Bagnaia and Gallo's family that can be associated with a repainting, see Figure 6. The areas characterized by a blue fluorescence correspond to grouting made to compensate for the lack of painted plaster. UVF also shows a general dark brown response of the surface due to a superimposed layer over the original paintings.

**Figure 6.** UVF photomosaic of the wall paintings before the restoration. The upper frieze (A) and the Riario coat of arms (B).

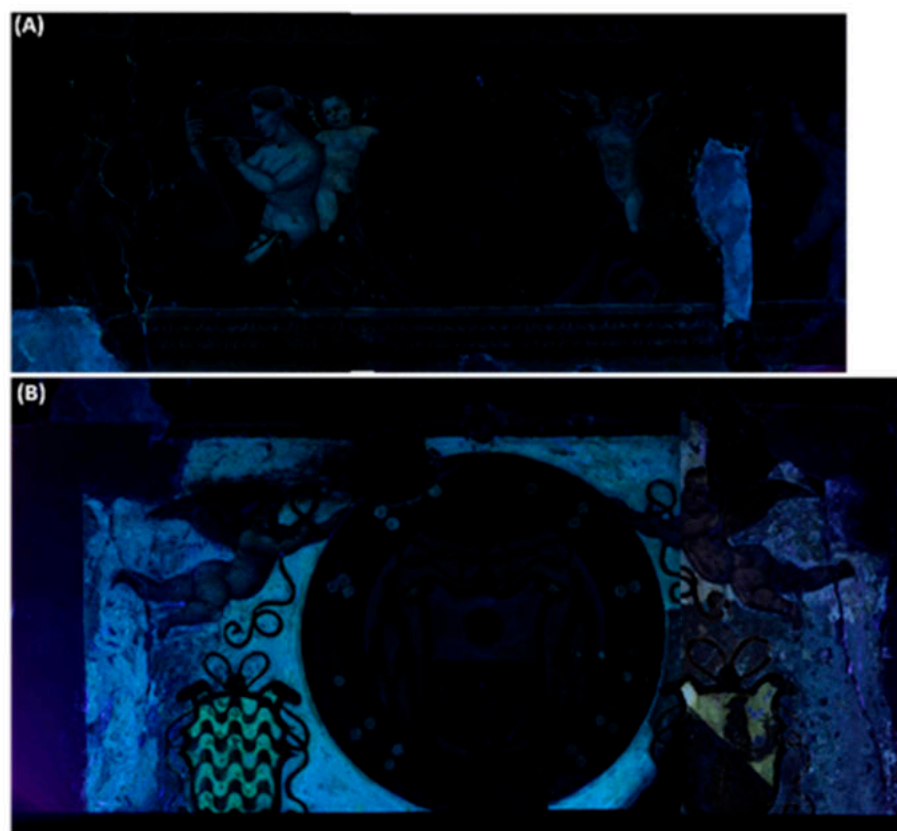
remaking on the wall, was almost completed. At this stage, UVF highlighted a general increase in the painting visibility due to the removal of the brown layer, especially in correspondence with the background in the lower painting, see Figure 7.

**Figure 7.** UVF photomosaic of the wall paintings after the almost complete removal of the *scialbo*. The upper frieze (A) and the Riario coat of arms (B).

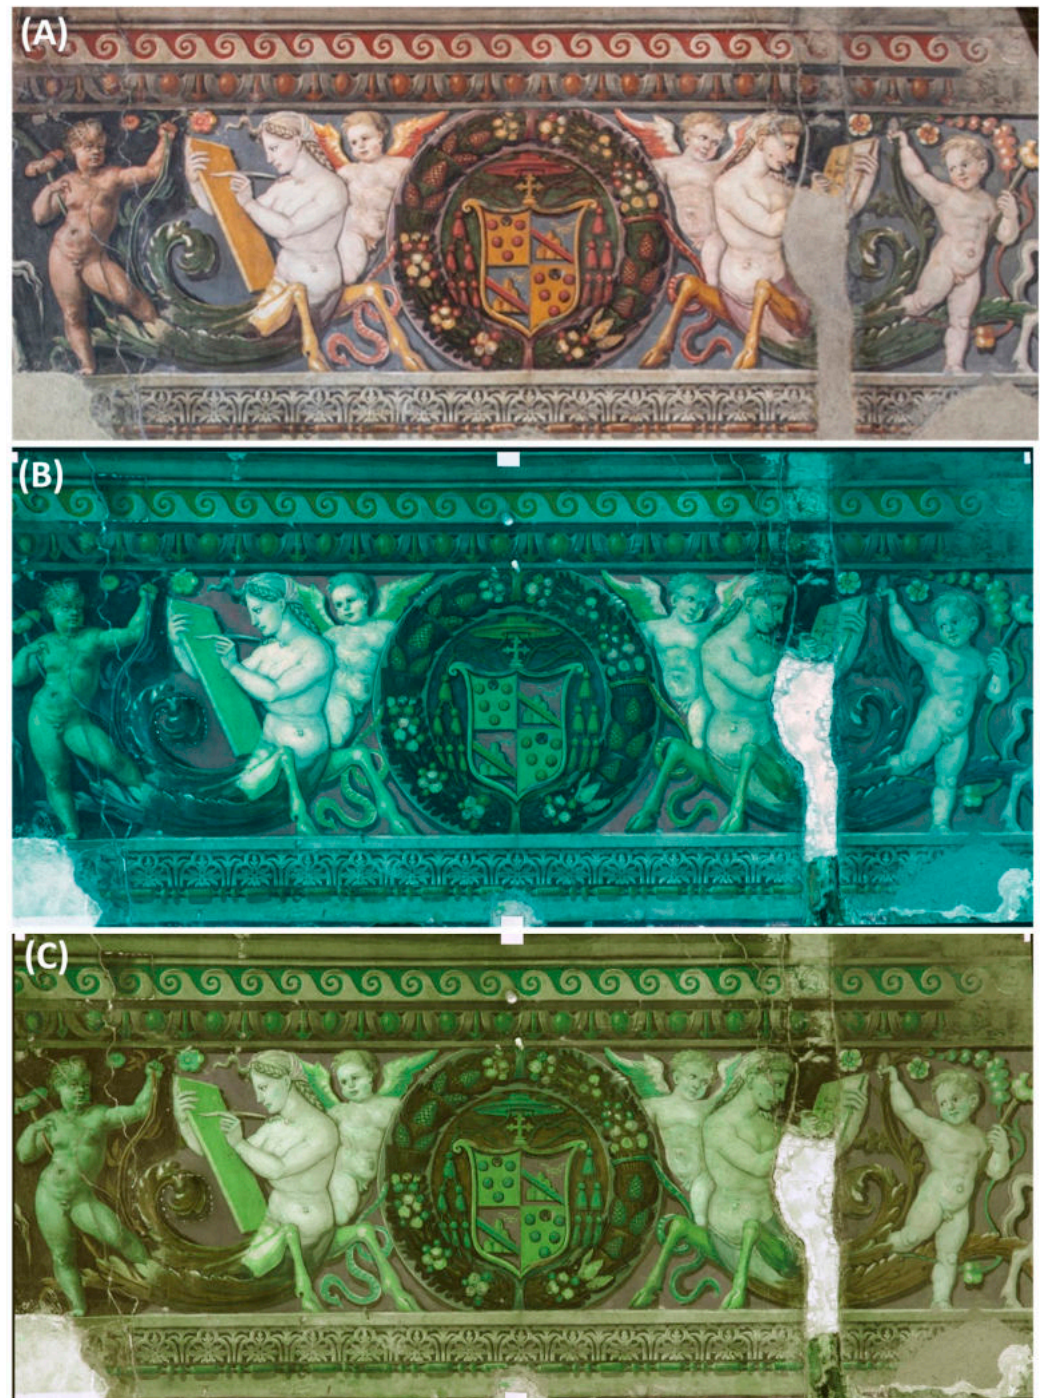
**Figure 8.** RGB (A), IRFC (B), and UVFC (C) images of the frieze after the complete removal of the *scialbo*, obtained with PickViewer<sup>®</sup>.

Green earth has a violet color in UVFC, whereas the emerald/Scheele's green appears dark brown (see the background of the coat of arms behind the red plumes). This appearance has been reported by other researchers as well [20].

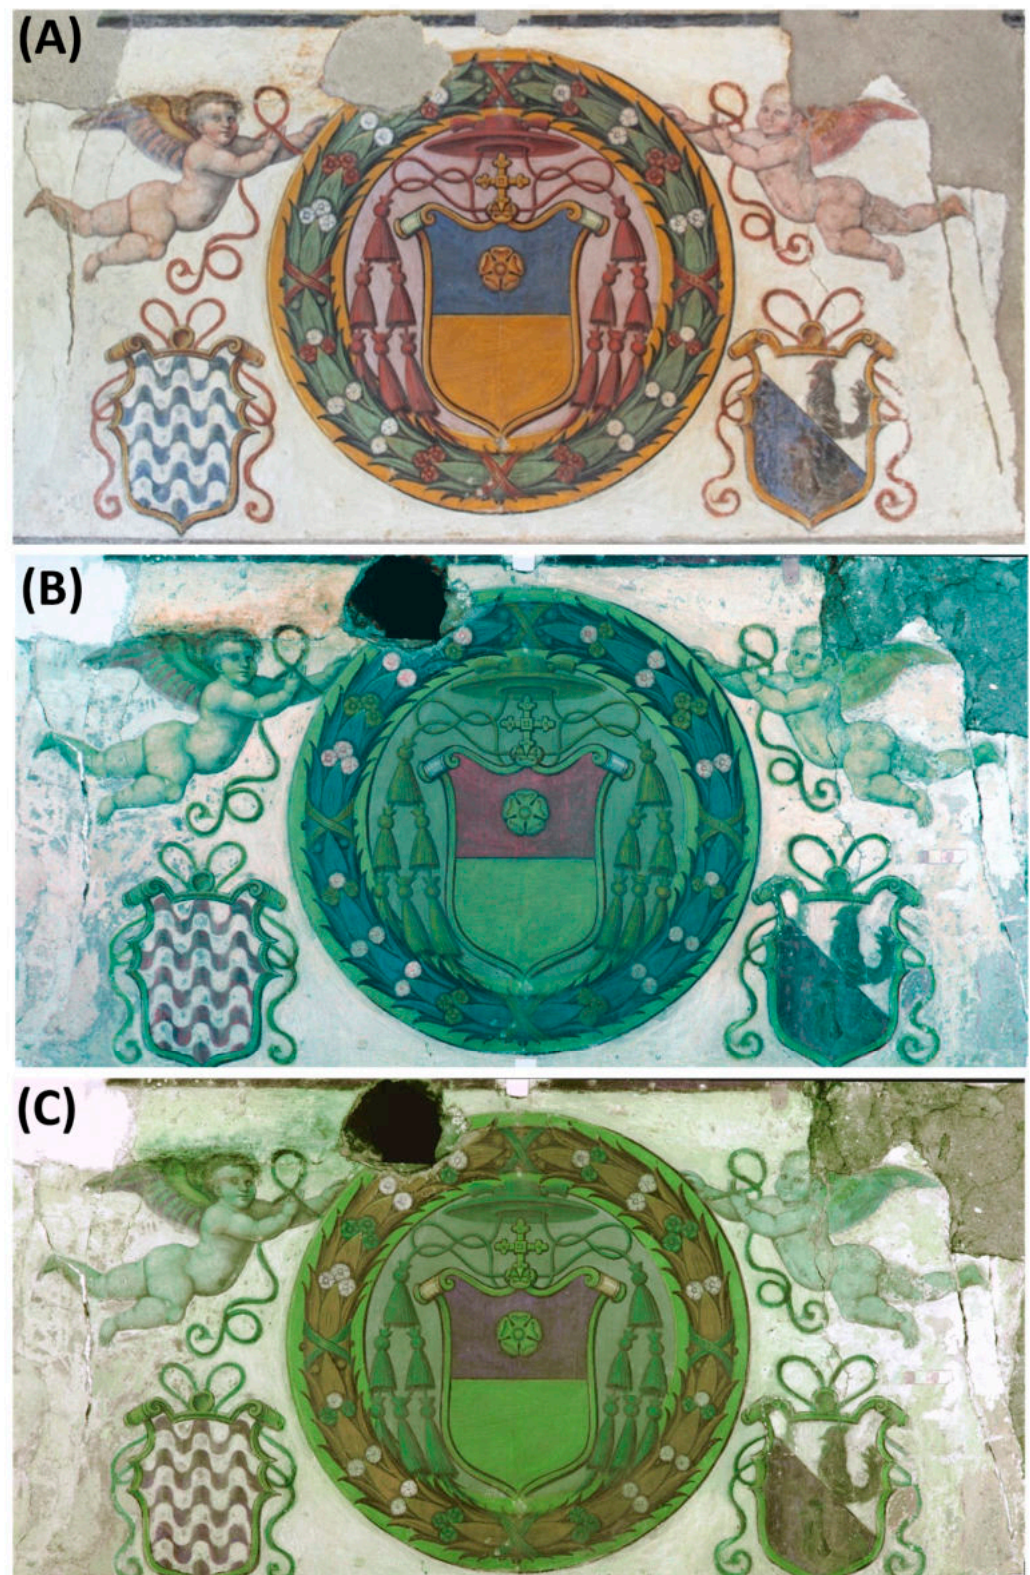
**Figure 9.** RGB (A), IRFC (B), and UVFC (C) images of the Riario coat of arms after the complete removal of the *scialbo*, obtained with PickViewer®.

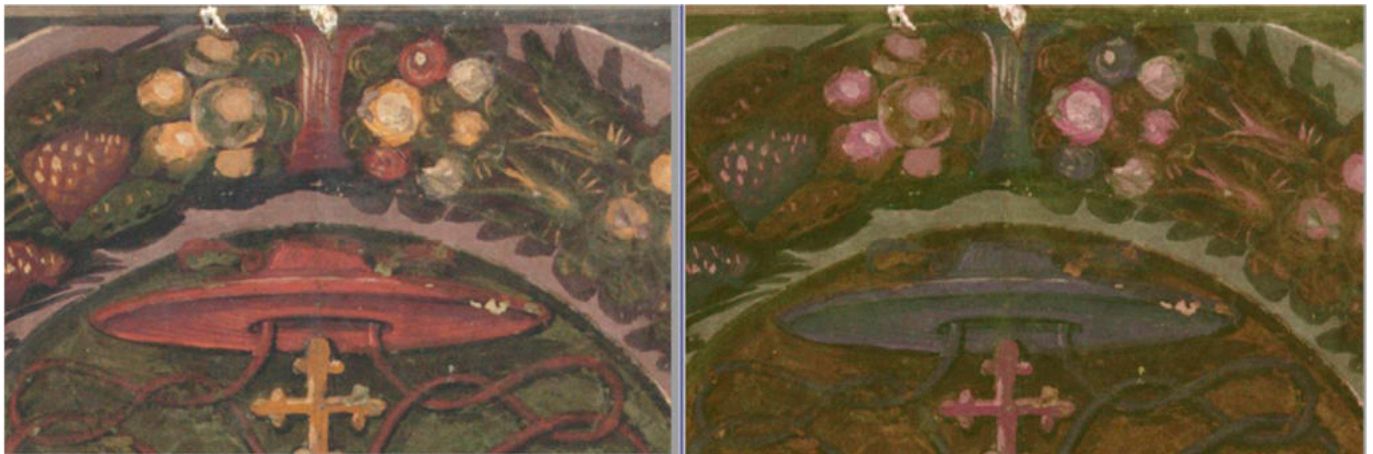
This part, in fact, acquired both a blue and pale-yellow fluorescence probably associated with organic binders. In the last step of the cleaning, UVF was pivotal for addressing the final interventions on the surfaces. In the same stage of the restoration, HMI was also applied to investigate the material distribution, to map the *scialbo* layer still present on the surface, and to check the effectiveness of the cleaning intervention. Specifically, this last goal was reached by applying the color measurement algorithm in PickViewer® (V. 1.1) software, proprietary software of the HMI equipment used here, to uncleaned and cleaned areas for comparing the chromatic coordinates. First of all, PickViewer® (V. 1.1) was used for obtaining the infrared and ultraviolet false color (IRFC and UVFC) images, see Figures 8 and 9, of the paintings that allowed for hypothesizing the composition of some pigments: blue smalt that appears as vine color in IRFC (Figure 8B), vermilion/cinnabar that becomes yellow, and different greens (earths and emerald green) that exhibited different response in false colors, especially in UVFC (Figure 9C) as better visible in a detail of the frieze, see Figure 10.

**Figure 10.** Detail of the frieze with the Cardinal's hat. RGB image on the left and UVFC on the right, as obtained by PickViewer®.

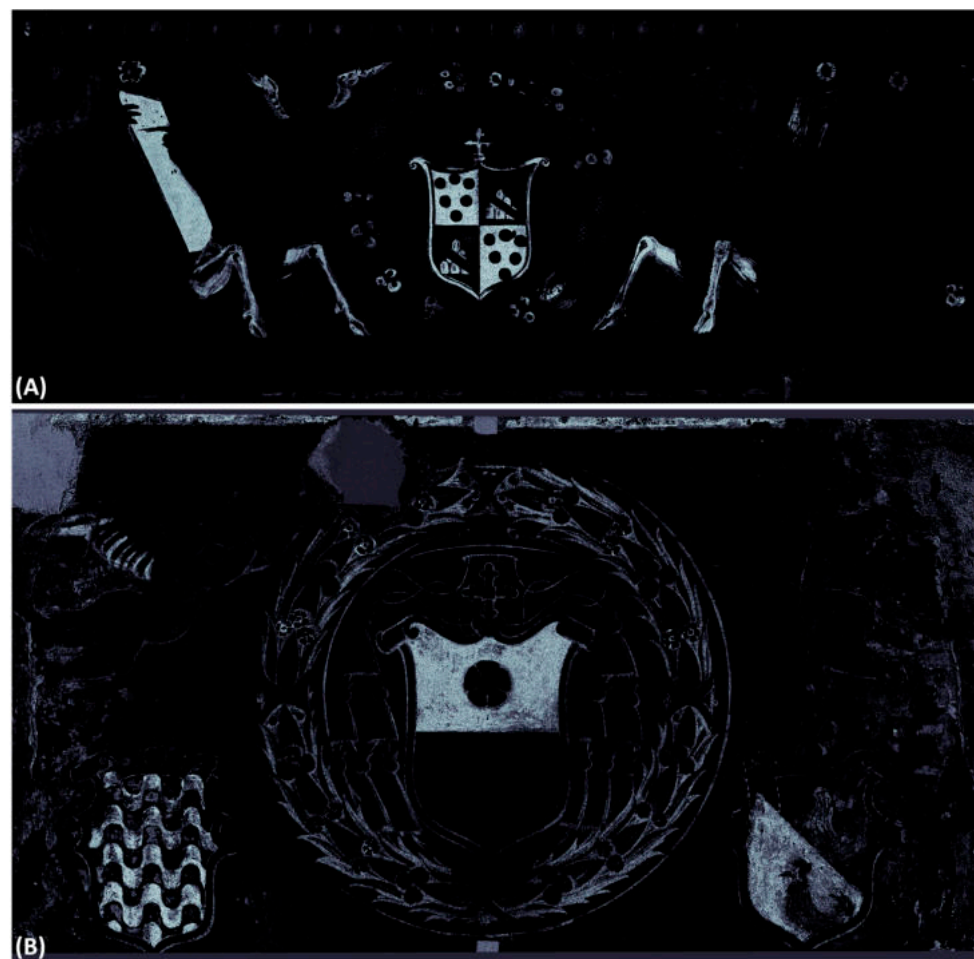
PickViewer<sup>®</sup> was used also for mapping different areas on the paintings, such as the blue color (due to smalt) in the Riario coat of arms and the yellow (characterized as ochre) in the frieze, by applying the spectral similarity algorithm (see Figure 11).

**Figure 11.** Result of the spectral similarity algorithm applied to the yellow ochre in the frieze (A) and in the blue smalt in the Riario coat of arms (B).

This algorithm allows for choosing a point in the RGB image and it compares the spectral reflectance at this point with those of the entire image. The result, as shown Figure 11, is a black and white image where the areas having the same spectral and chromatic characteristics of the selected point appear white. In this way, it is possible to map the areas of the painting with the same spectral and chromatic characteristics.

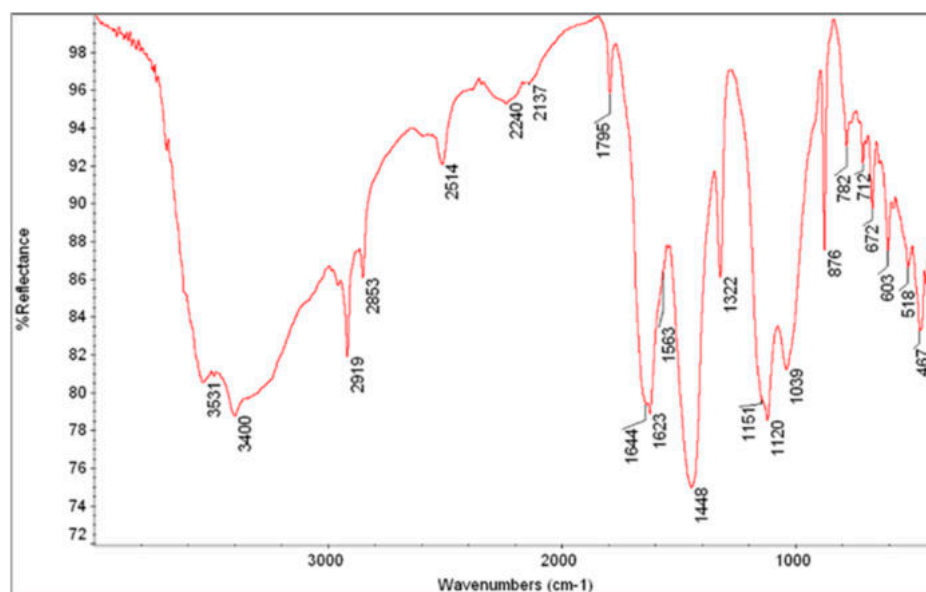
The presence of organic materials has been confirmed by FTIR spectroscopy performed on two microsamples of the paintings. FTIR showed traces of proteins (characteristic bands at 1644, 1563, and 1448  $\text{cm}^{-1}$ , partially overlapped with those of gypsum and calcium carbonate), lipidic substances (oils and/or wax with the characteristic strong signatures at 2919 and 2853  $\text{cm}^{-1}$  due to C-H stretching of long-chain molecules) and abundant gypsum

(bands at  $\text{cm}^{-1}$ : 3531, 3400, 2240, 2317, 1623, 1151, 1120, 672, 603, and 467), probably used in the grouting, see Figure 12 [24].

**Figure 12.** Spectrum of a sample taken from the upper frieze in correspondence with a brown surface layer.

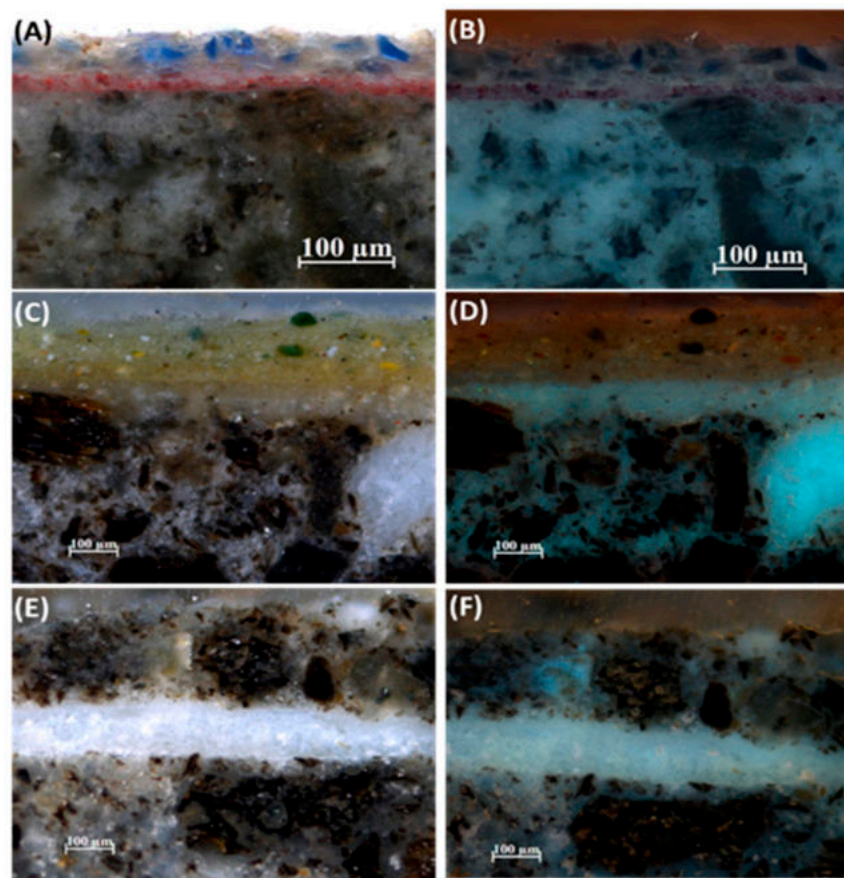
In Figure 13, the cross-sections under reflected light and ultraviolet fluorescence of three microsamples are shown. The first sample comes from the light blue background of the frieze: over the dark mortar (made of lime and pozzolanic materials) a red layer was applied as preparatory ground for blue smalt, whose pale blue grains are well visible in the cross-section. Because smalt is a glass, the grains are transparent and characterized by conchoidal fractures with typical thin, sharp edges of glass splinters. The second sample examined as a cross-section is taken from the background of the Riario's coat of arms that appeared clearly repainted. In the cross section shown in Figure 13B,C, the presence of a white layer is evident, a sort of *scialbo*, which is in turn covered by thick yellow layers (probably repainting), the surface appearing greenish in color. The third sample comes from the Riario's coat of arms corresponding to the right foot of the winged putto on the right of the painting area. In this sample, it can also be observed the white *scialbo* covered by an evidently new layer of repainting.

**Figure 13.** Microphotographs of cross-sections from the three samples. (A,C,E) reflected light; (B,D,F) ultraviolet fluorescence.

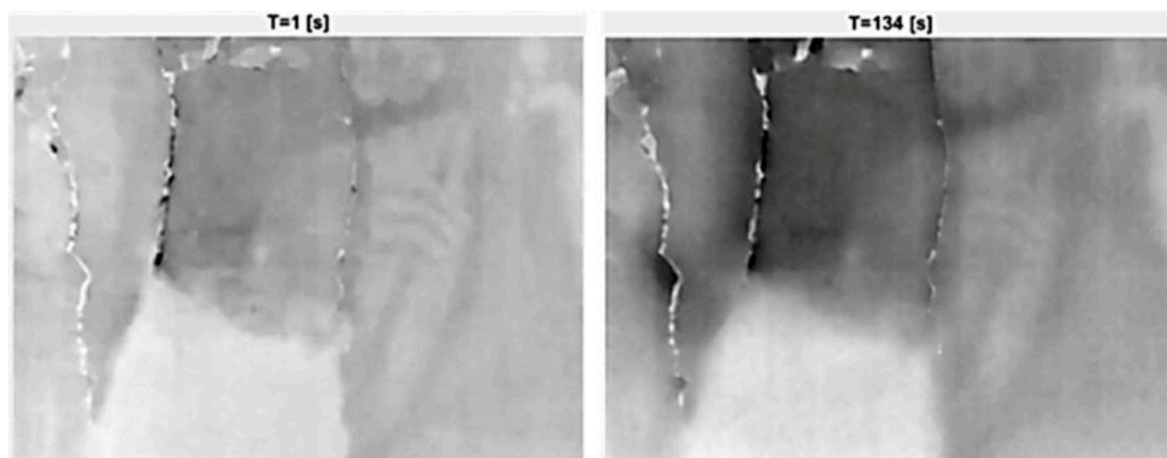
The restoration was aimed at first solving the most urgent critical issues of the paintings: the serious adhesion defects in the frieze with the deformation of the plaster, and the removal of the *scialbo* layer applied around the paintings above the fireplace, visible in the PuCT emissivity images, see Figure 14.

**Figure 14.** Emissivity images at 1 s and 134 s of a portion of the frieze obtained using PuCT before consolidation, showing deep cracking, detachment, and deformations.

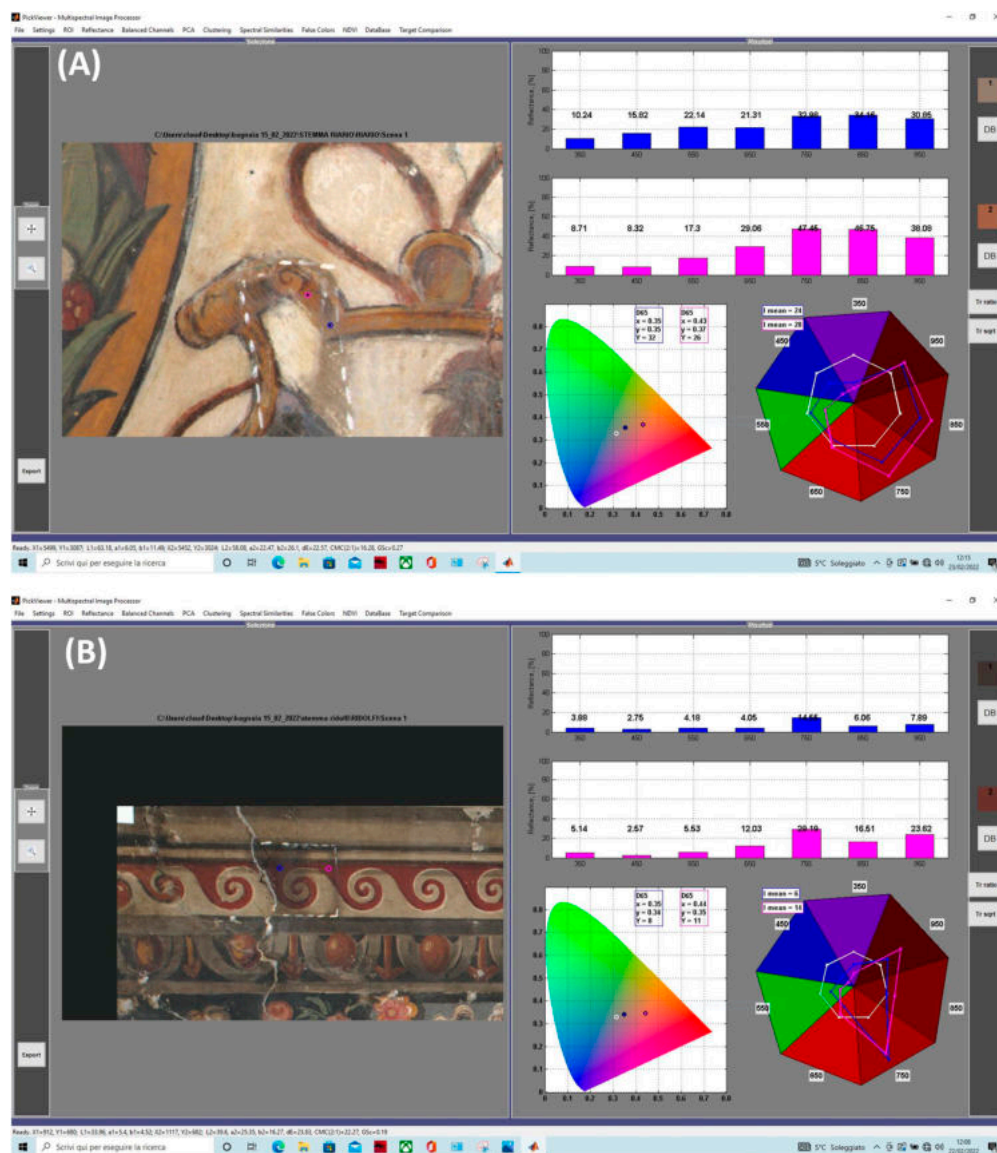
**Figure 15.** Chromatic and reflectance comparison between cleaned and uncleared areas on the yellow color in the Riario coat of arms (A) and on the red color in the frieze (B) showing a clear increase in saturation due to the removal of the surface soot layer.

In Figure 15, two examples of chromatic variation due to the surface blackish layer are shown: one for the yellow in the Riario coat of arms (Figure 15A) and the other for the red in the frieze decoration (Figure 15B). Yellow underwent a significant increase in saturation with values of  $a^*$  and  $b^*$  chromatic coordinates changing from 6.05 and 11.49 to 22.47 and 26.10, respectively; the values were calculated by the specific algorithm in PickViewer<sup>®</sup> and reported in the bar under the image in the graphical user interface of the software. The values before cleaning are indicated as L1,  $a_1$ , and  $b_1$ , and those after cleaning as L2,  $a_2$ , and  $b_2$ . The color measurements are possible owing to the procedure used by the HMI system based on calibration of the acquired images with the use of reference white patches and the colorchecker. This procedure allowed for obtaining calibrated images centered at specific wavelengths whose reflectance and color data are characterized by high precision (verified by Profilocolor by using a laboratory spectroradiometer) [25,26].

In Figure 15, the CIE1931 xyY color coordinates are also reported together with the position of the two selected points (the blue is referred to as the uncleaned area and the pink as the cleaned one). The values of reflectance are reported in the upper right side of the graphic user interface of PickViewer<sup>®</sup> by using blue (uncleaned area) and pink bars (cleaned). The main changes occur at 650 nm (increase in reflectance) and in the IR, further indicating an increase in yellow saturation.

Additionally, in the case of red color in the frieze, the chromatic coordinates underwent a significant increase:  $L^*$  changed from 33.96 to 39.60,  $a^*$  from 5.40 to 25.35, and  $b^*$  from 4.52 to 16.27, indicating a clear increase in saturation.

After a color-fastness test, the cleaning was carried out. The detachments of the pictorial layer were treated with a microacrylic resin (K52) in a solution of water and

isopropyl alcohol (1:1) at 20%, when deemed necessary. In this way, the removal of the superimposed layers was performed in safety, fixing the most critical areas between the different layers. The same 10% resin was used to consolidate the vermilion/cinnabar, which had areas of slight surface decohesion. Cleaning was carried out with water and 2% Tween 20 surfactant supported by Japanese paper (17 g). Repeating the operation as necessary, this allowed the nature and quantity of the superimposed layers to be fully examined. A total of 13 recent layers were found, sometimes discontinuous, then mechanically removed with a scalpel. The *scialbo* removal (*descialbo*) was performed step-by-step with the use of stratigraphic test areas, small *descialbo* zones studies on similar decorations for epoch, and context and imaging diagnostics, see Figure 15.

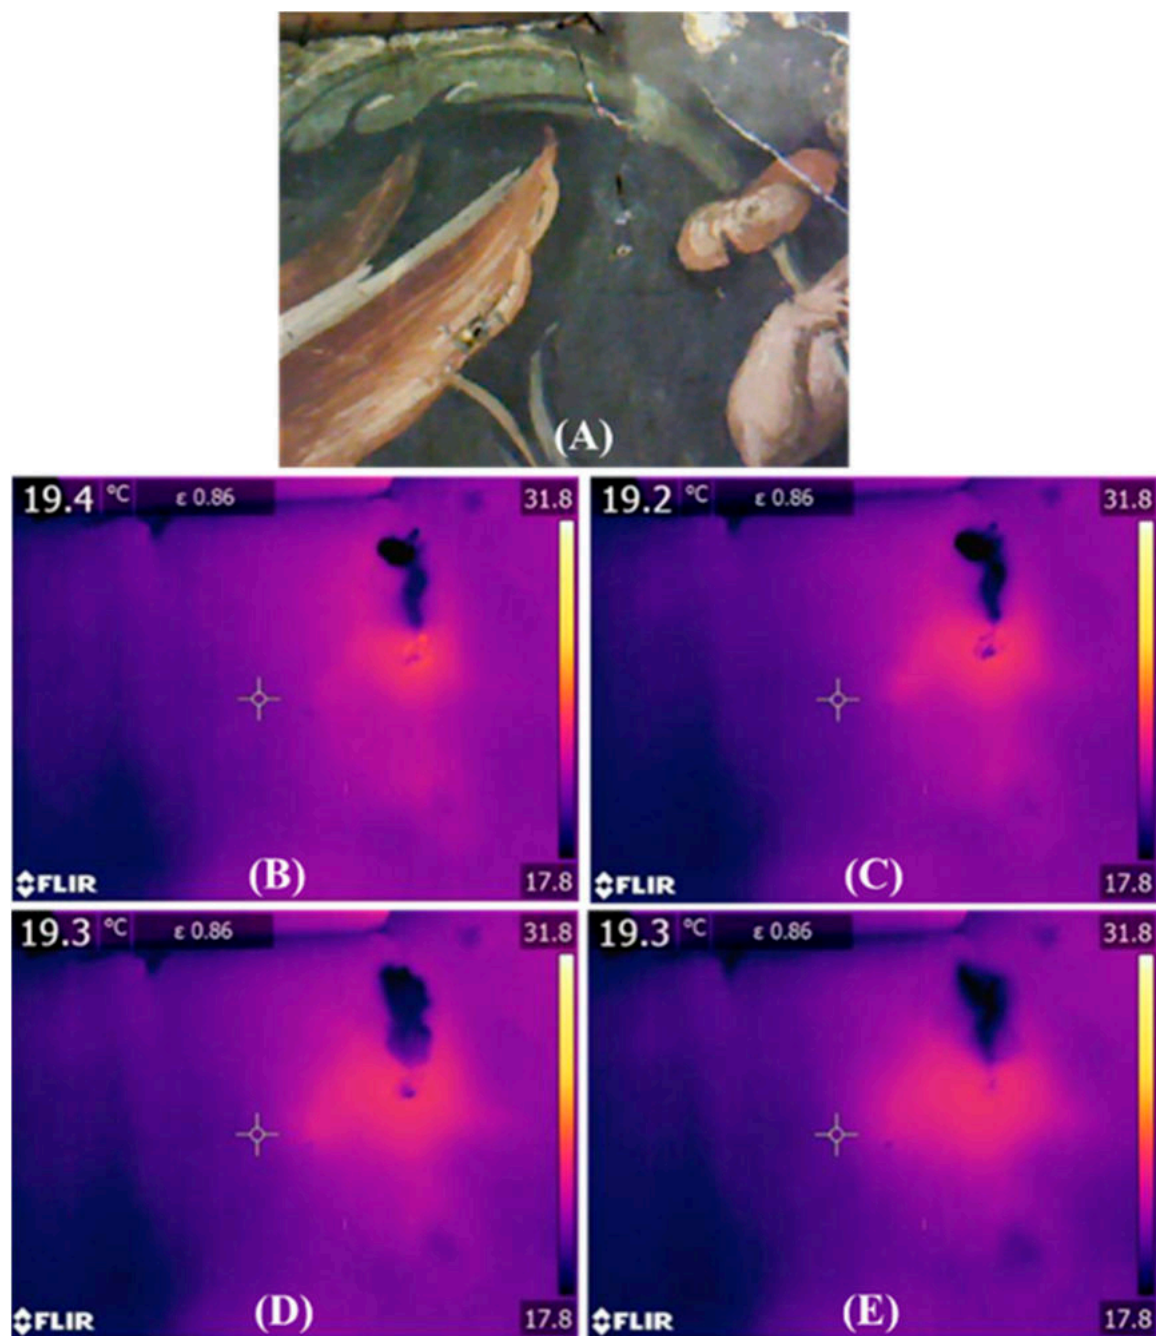
**Figure 16.** RGB image (A) and timeline of thermograms (B–E) of the area investigated with passive thermography where the (warmer) Ledan is visible spreading in the preparatory layers after injection by a syringe. Image (E) has been taken after 5 min.

The consolidation of the preparatory layers was important to recover the artwork, and it was studied carefully by thermography. The adhesion between the preparatory layers was restored through injections of various hydraulic mortars (from Ledan series), with special attention to the deformed area. The major gaps were fixed here through the creation of pins made of Ledan Adesiva. After setting the product, a filling with a mixture of Ledan Ristat B and Ledan Ristat Extra was applied. This mixture has excellent adhesive, filling, and light characteristics. In the case of well-circumscribed detachments, the Ledan TB1 was used by monitoring the consolidant penetration with the thermal camera to verify the effectiveness of the consolidation, see Figure 16.

It is worth noting that the quantities of hydraulic mortar used to compensate for the various adhesion defects are 5 kg of Ledan TB1, 1.4 kg of Ledan Ristat B, 1.4 kg of Ledan Ristat Extra, and 100 g of Ledan Adesiva, which suggest the large extent of the detachments and the consolidation work.

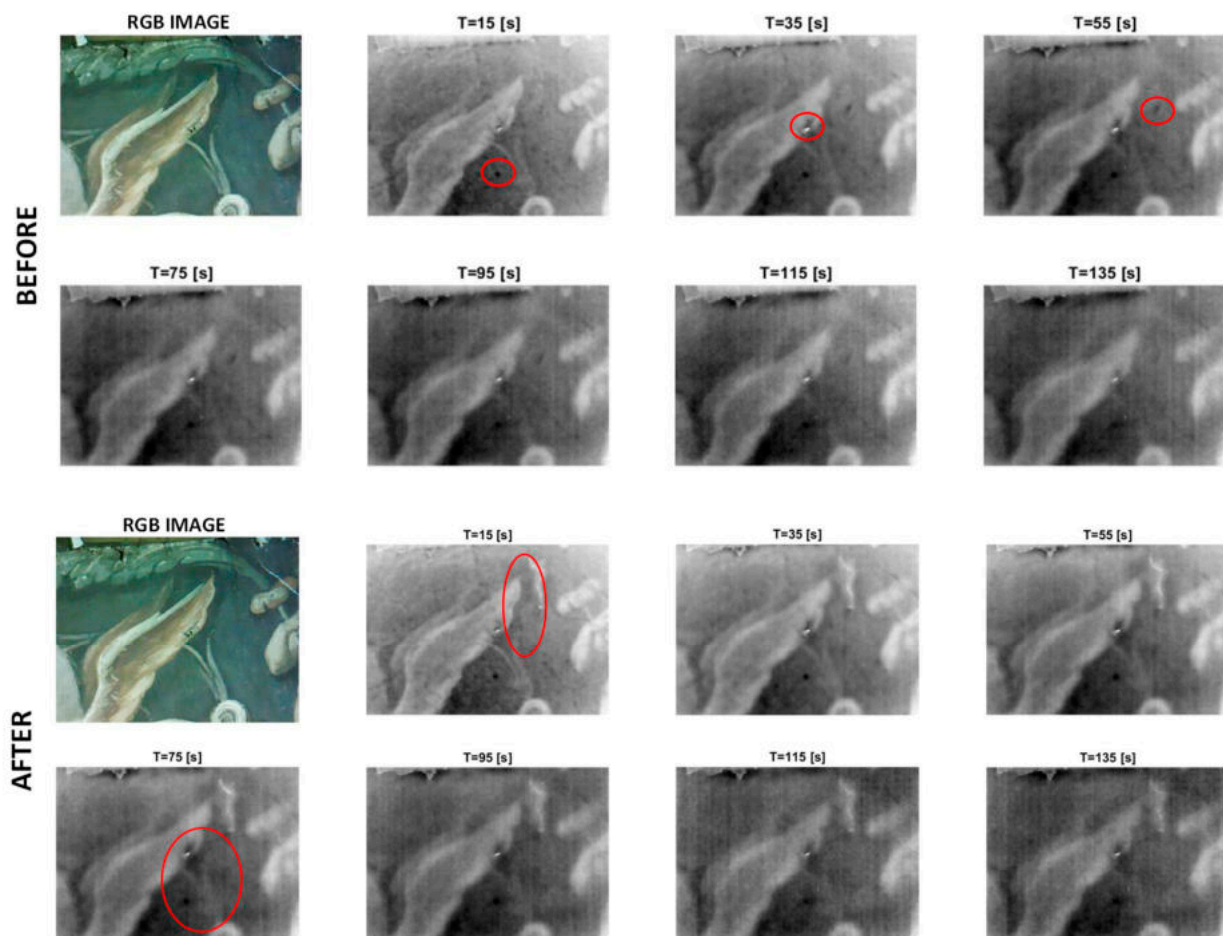
The emissivity images over time obtained with PuCT show some anomalies (highlighted by yellow circles): the appearance of the crack after having been infiltrated by water and alcohol, and how the dark areas are less intense after the injection (Figure 17) [27].

**Figure 17.** Sequence of emissivity images at different times obtained through PuCT before and after Ledan injection.

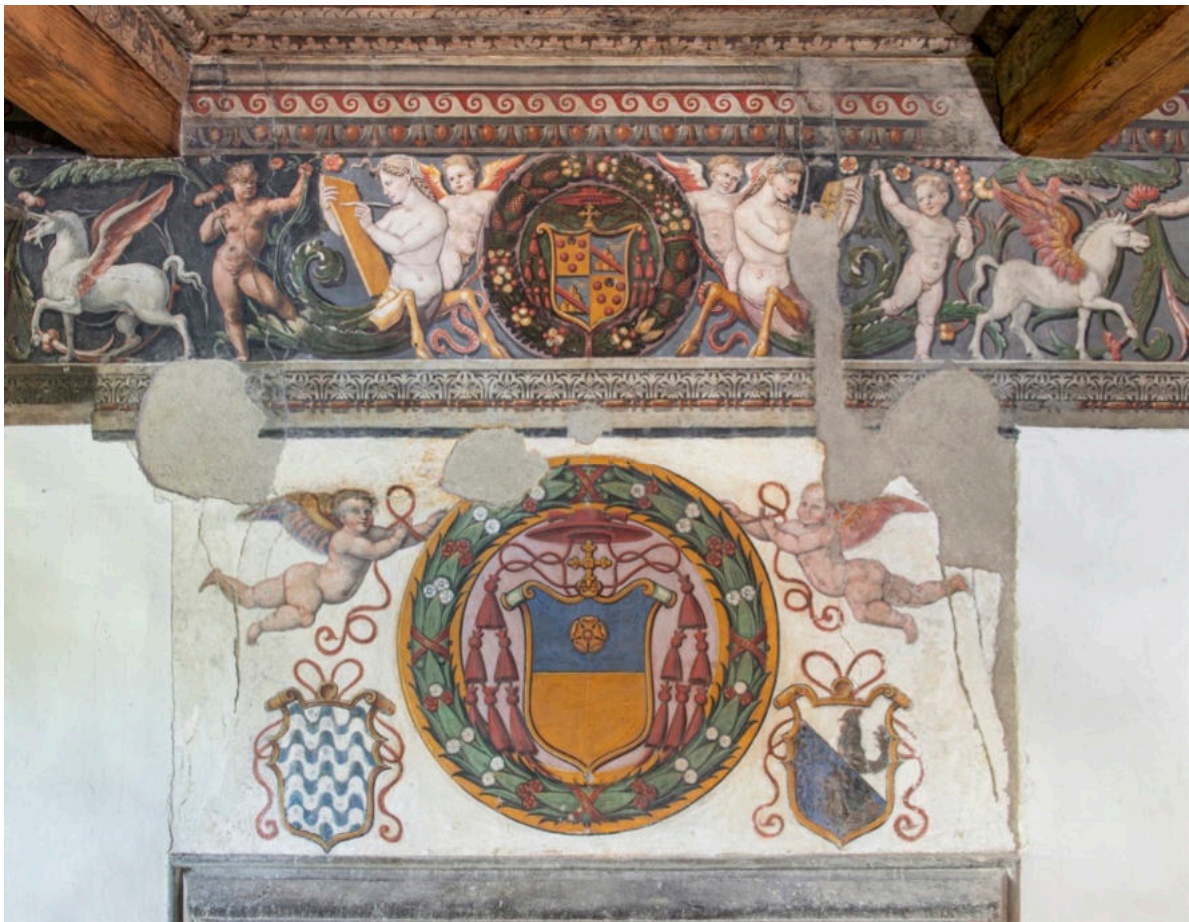
**Figure 18.** The wall paintings after the restoration. Photograph by Gaetano Alfano.

After this consolidation work on the painting ground layers, the previous grouting materials, unsuitable and incompatible with the original materials, were mechanically removed. The brick support was restored in correspondence with the through-hole of the kitchen, and the large grouting was subsequently treated with a sublevel approach. The painting-level grouting was mimetically reintegrated, while all the abrasions, lacunae, whitening, and lack of patina were treated with lowering of tone. With an overall chromatic balance, the painting is once again legible, vivid in the colors, fully showing the compositional rhythm and the refined pictorial taste of the workshop of the artists working in Palazzo Gallo, see Figure 18.
