# 3D Photogrammetric Survey, Raking Light Photography and Mapping of Degradation Phenomena of the Early Renaissance Wall Paintings by Saturnino Gatti—Case Study of the St. Panfilo Church in Tornimparte (L'Aquila, Italy)

**Abstract:** This paper provides the results of a 3D photogrammetric survey of the apsidal conch of St. Panfilo Church in Tornimparte (L'Aquila, Italy). The images were acquired and then processed in order to obtain a three-dimensional model available on Sketchfab platform. The five panels and the vault of the apsidal conch were exported from the 3D model as orthomosaics and then imported into CAD software for the mapping of the main degradation phenomena. The examined surface was almost entirely covered by mural painting and restoring mortars, the latter mainly located in the lower part of the apsidal conch. The whole surface of the apsidal conch was also examined by means of raking light that enabled highlighting of conservation problems and the presence of incision marks and *giornata/pontate* boundaries indicating the use of the *fresco* painting technique. Several degradation phenomena, attributable both to the executive technique of wall painting and the mic

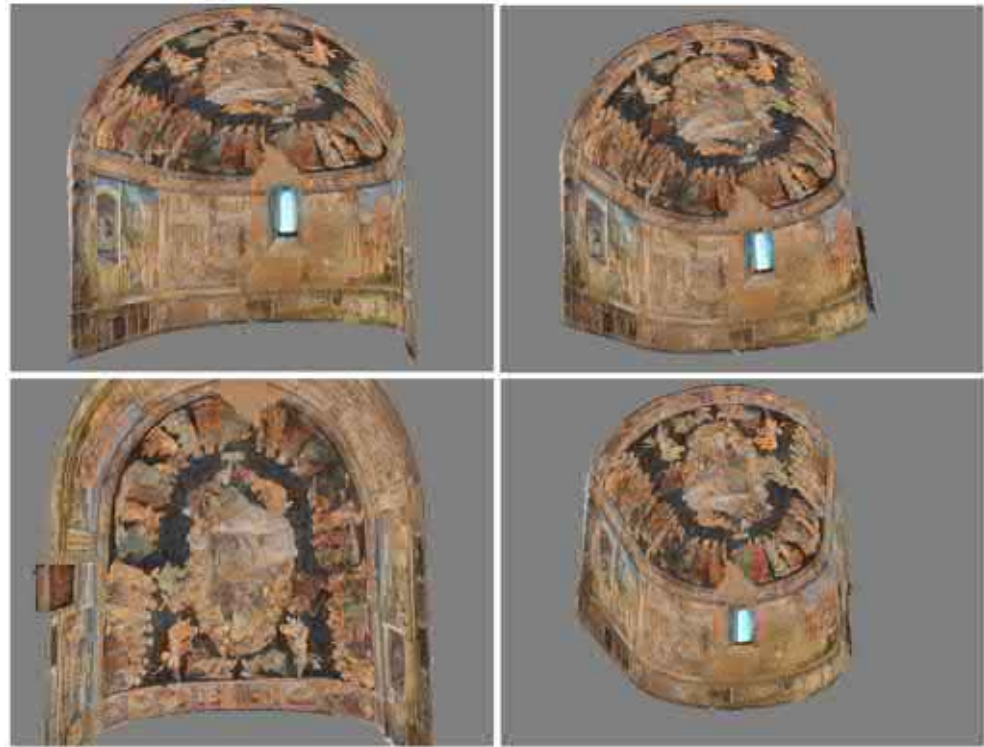
**Figure 1.** Four views of the apsidal conch from the 3D rendering model.

Moreover, Figure 1 shows additional views of the 3D model. The model can be used for mapping the state of conservation, the execution techniques, the eventual restoration areas and for georeferencing the analysis performed in the various part of the painting on the occasion of the development of the AIAR Tornimparte project.

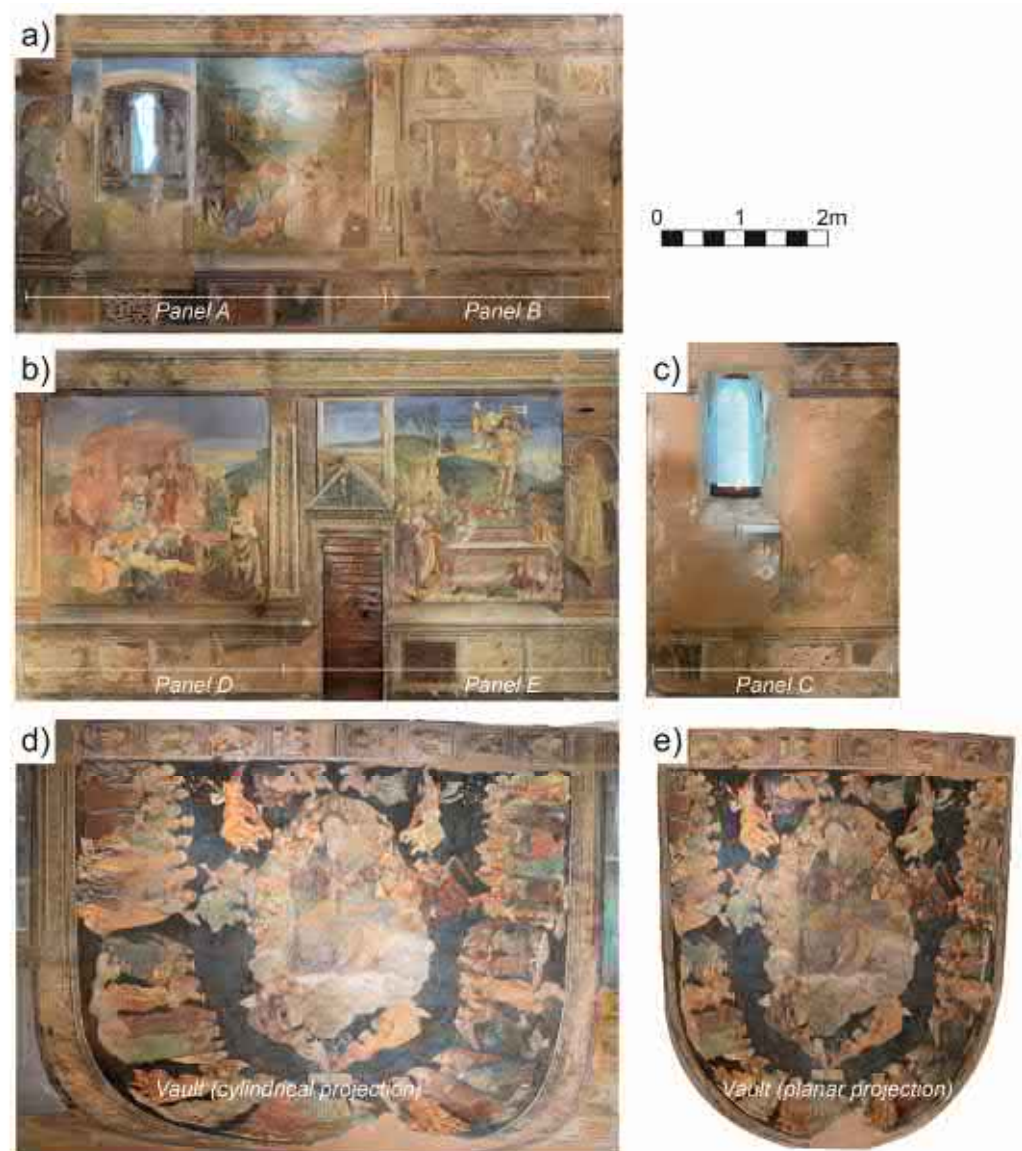
**Figure 2.** Orthomosaics of the apsidal conch: (a) panels A and B depicting the Taking and the Flagellation of Christ, respectively; (b) panels D and E depicting the Deposition and the Resurrection of Christ, respectively; (c) panel C originally depicting the Crucifixion; (d,e) cylindrical and planar projections of the vault (not to scale) depicting God the Father along with the Angels and Blessed in Paradise.

The lower part of the apsidal conch consists of five panels depicting scenes from the New Testament (Figure 2). Nevertheless, only panels A, D and E show original paintings with well recognizable scenes. Conversely, the flagellation of Christ depicted on the panel C is not recognizable because of the creation of a new painting during the XVII century [1]. Lastly, the original painting of panel C, which was originally supposed to depict the Crucifixion, has completely disappeared due to extensive restoration works.

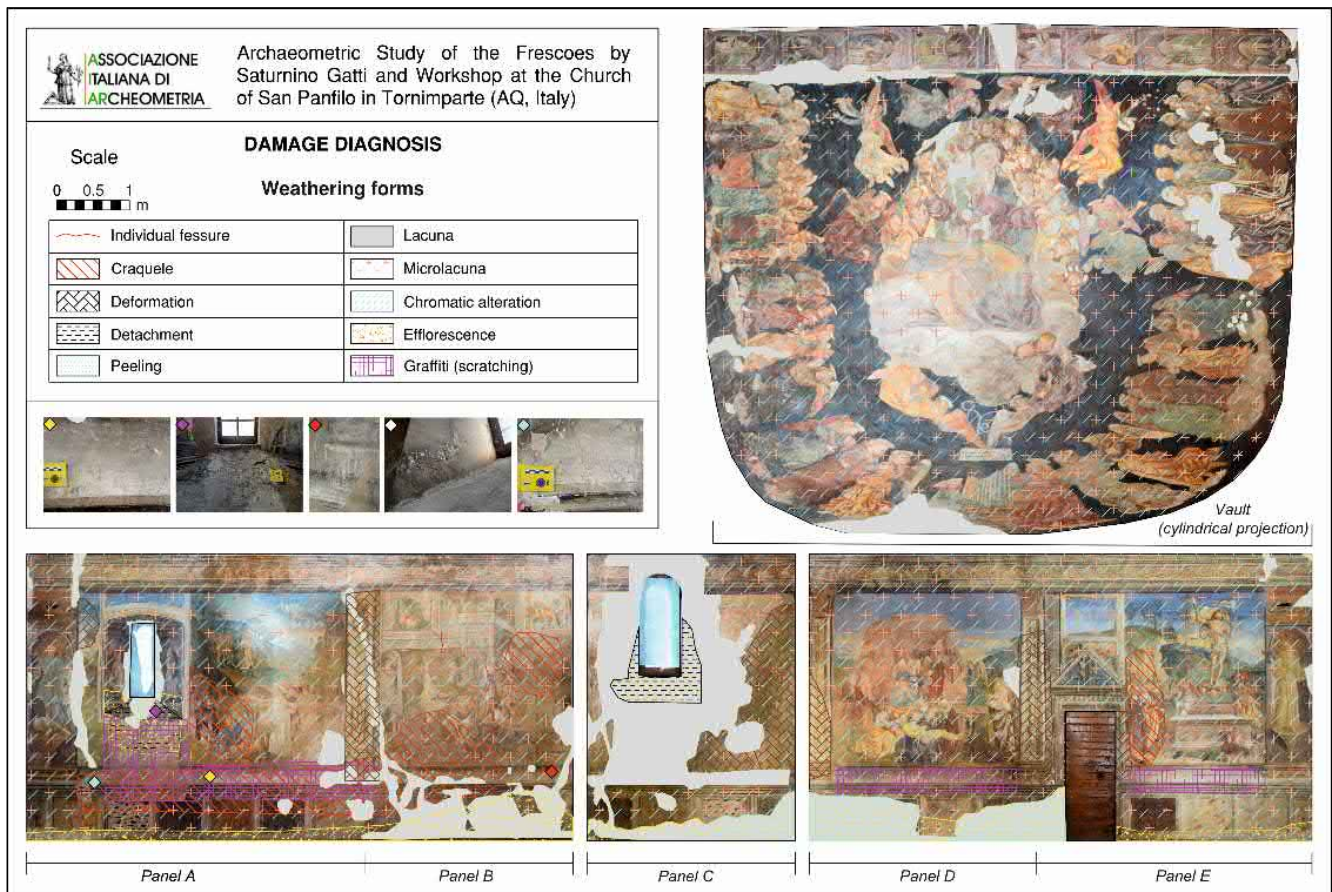
Among the main weathering forms (Figures S2 and 9), individual fissures and intense networks of minor cracks (*craquele*), mainly extending on the decorated surfaces, can be observed. This kind of fissuring often evolves from minor detachments affecting the pictorial layers (Figure S2).

**Figure 9.** Distribution of the weathering forms affecting the five panels and the vault of the apsidal conch of St. Panfilo Church in Tornimparte (AQ, Italy). Coloured dots indicate the position of the acquired pictures in the wall paintings.
