# WALL PAINTING RESTORATION AND CONSERVATION IN THE NEW CHURCH OF TOKALI IN GOREME'S OPEN AIR MUSEUM

**Maria ANDALORO\***  
**Murat E. GÜLYAZ**  
**Paola POGLIANI**  
**Hatice TEMUR**

## I- RESTORATION OF THE WALL PAINTINGS OF THE NEW CHURCH OF TOKALI

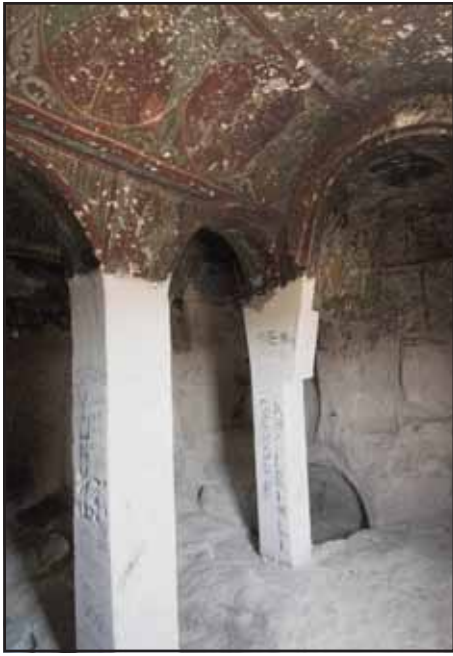
Fig. 4: Şahinefendi, the church of Fourty Martirs, interior. View of the south aisle and south apse before restoration.

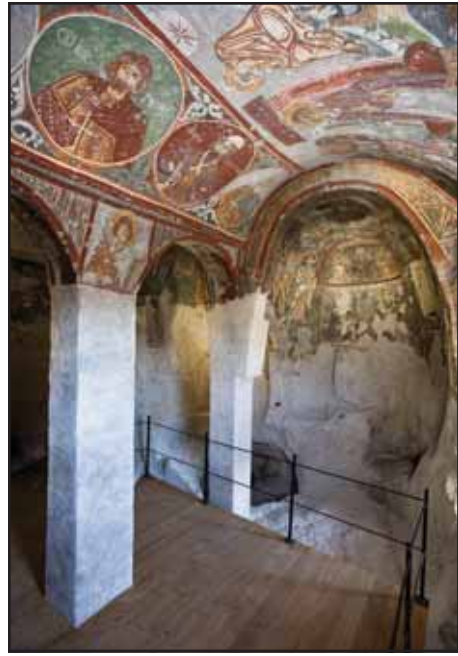
Fig. 5: Şahinefendi, the church of Fourty Martirs, interior. View of the south aisle and south apse after restoration.

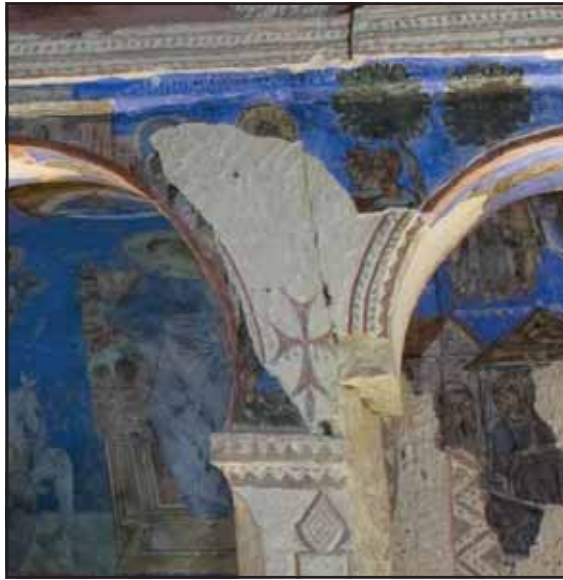
In the case of the crack in the second arch, above the lacuna of the pillar (fig. 8), on the surface of the soffit there is a fine crack which completely crosses the arch diagonally (from the edge of the lacuna: 50 cm on the left side and 75 cm on the right side) and then continues on the adjacent walls (west wall of the corridor and east wall of the naos) for about 10-15 cm to then disappear beneath the painted plaster in the direction of the main fissure travelling in a vertical direction.

While the main fissure corresponds to a natural vein in the stone, the horizontal crack under the arch occurred due to static instability, perhaps when the section below the pillar collapsed or perhaps even more recently due to the lack of a support where the weight can be discharged, perhaps prompted by telluric events or other vibrations from the ground.

The available data has not enabled us to establish whether the fracture in the portion of rock is complete and therefore if the fragment is detached but held in place due to mechanical adhesions, nor was it possible to know how long this equilibrium has existed. The fragment in question is approximately 80 cm wide (the width of the arch), an average of 60 cm high from the outer side and approximately 1 m from the inner side. Its thickness ranges from 10 cm at the base to 40 cm in the top parts (inner side of the corridor, but greater from the top of the naos), covering an approximate volume of 0.30 – 0.40 m<sup>3</sup> and having a conceivable weight of approximately 550 – 600 kg (specific weight of tuff approximately 1800kg/m<sup>3</sup>).

Fig. 8 Göreme Open Air Museum, New Church of Tokalı. The cracks on the rocky support in the second arch above the lacuna of the pillar.

Considering the severity of the crack affecting the second arch from the north and exploiting the presence of the scaffolding underneath the arch still present for this work campaign, the decision was made to intervene to secure the fractured block. The intervention involved the insertion of 2 dowel rods which, crossing the detached part and entering the main body of the rock, prevent the large fragment from sliding downwards.

The 2 holes were drilled to different depths in order to intercept the plane of the fracture which runs in a non-parallel course along the surface of the soffit and therefore both enter the sound part of the pillar for approximately 15 cm (25 cm for the right dowel rod and 40 cm the left one). The dowel rods were inserted into the lower part of the fragment, where there is no painting, up to 20 cm from the vertical sides of the arch and 24 cm from the horizontal plane of the fracture. The holes were made with a low-speed electric drill

with no impact. The rods were inserted slightly below the surface of the rock of the soffit and were then stuccoed in a mimetic fashion.

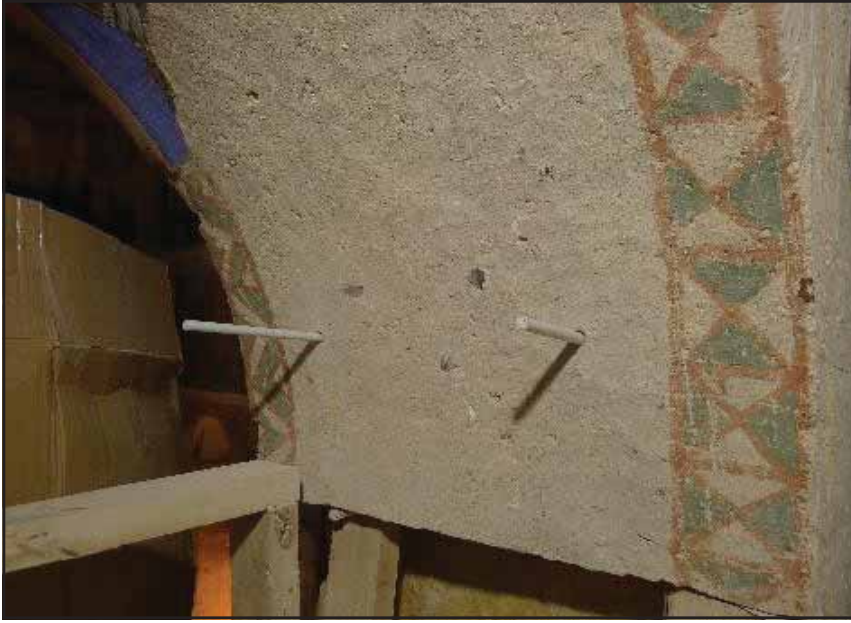
Fig. 9: Göreme Open Air Museum, New Church of Tokalı. Secon pillar, intervention with the insertion of 2 dowel rods.

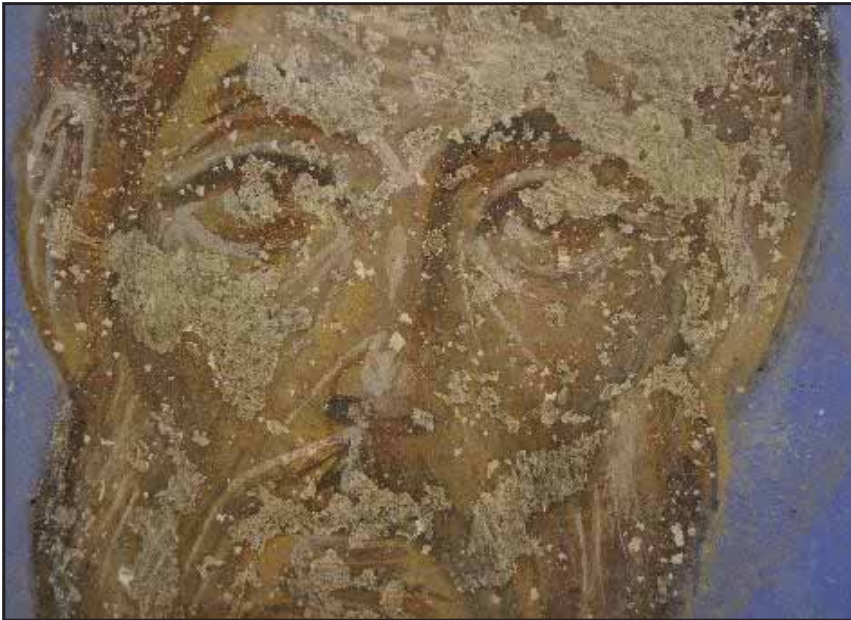
The main problem of conservation, found to be rather widespread on the entire surface of the painting, but with areas of greater concentration on some colours, is the detachment of the pictorial layer in flakes. This phenomenon seems to follow the form of the fine craquelure affecting the colour layer with greater or lesser severity, above all along the edges of the existing lacunas. In correspondence to the most recent lacunas, the slight de-cohesion of the support mortar can also be noted.

Fig. 10: Göreme Open Air Museum, New Church of Tokalı. Corridor. Particoular of the state of preservation of the painting layer.

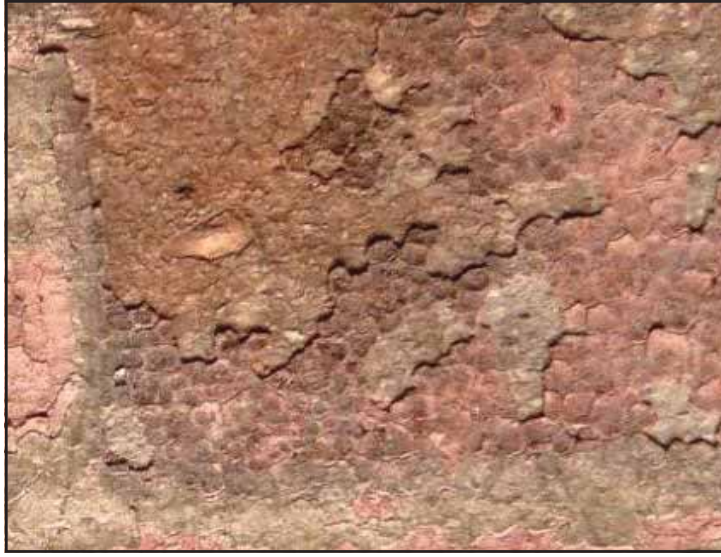
Fig. 11: Göreme Open Air Museum, New Church of Tokalı. Corridor.  
Particoular of the state of preservation of the painting layer.

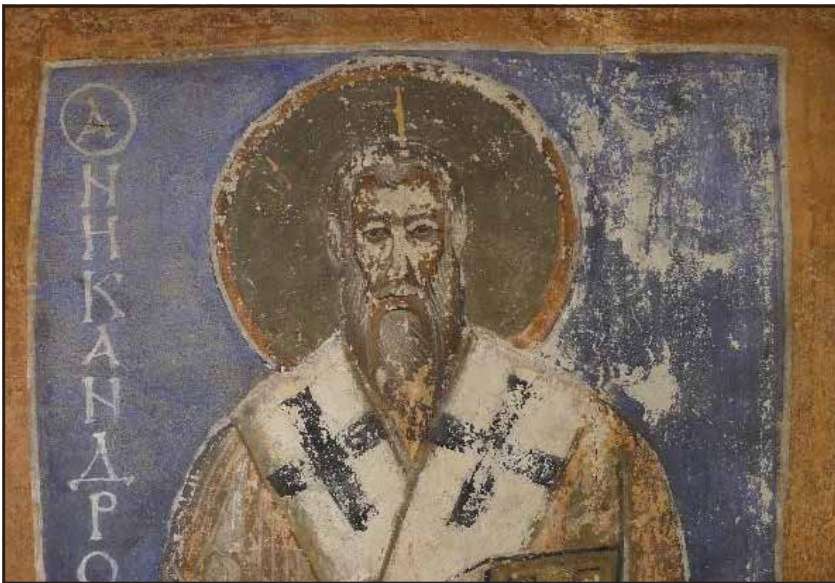
Fig. 14: Göreme Open Air Museum, New Church of Tokali. Corridor, St. Nicandro of Myra before the restoration

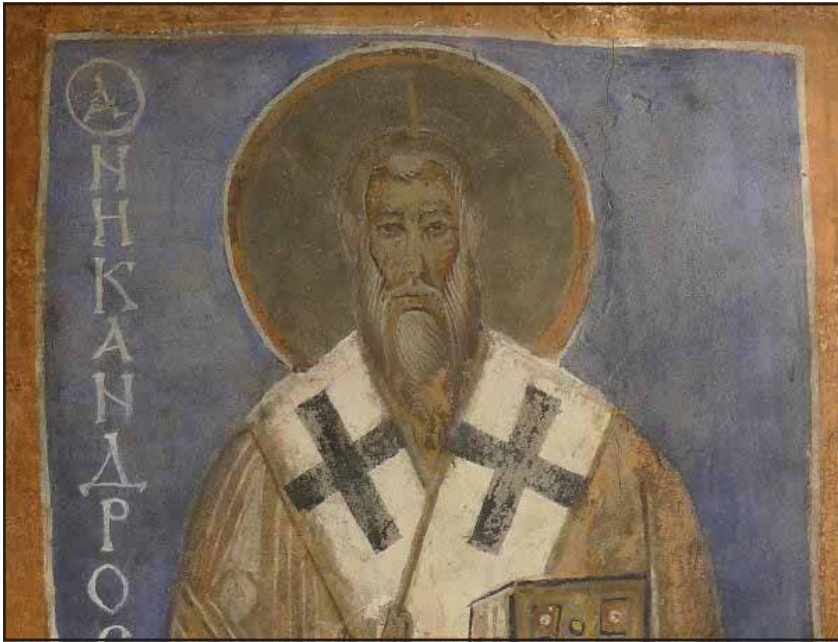
Fig. 15: Göreme Open Air Museum, New Church of Tokalı. Corridor, St. Nicandro of Myra after the restoration
