A METHODOLOGICAL APPROACH TO THE SAFEGUARD OF THE WOODEN DOOR OF TODI CATHEDRAL

Giorgia Genco, Claudia Maura, Angela Lo Monaco, Maurizio Marabelli, Claudia Pelosi
Tuscia University, Viterbo, Italy
Correspondence to: genco@unitus.it

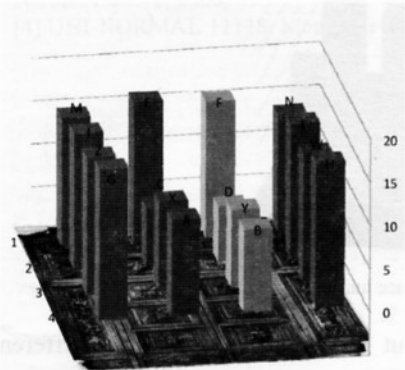
The microclimatic parameters are in fact much more variable near the door because of the close contact with outdoors. The analysis of the punctual measurements gave an important contribution to the knowledge of the microclimatic conditions of the door that affect its physical and mechanical properties. The winter temperature graph shows an heterogeneous distribution of the values (fig. 2). The lower T values were registered on the C and D points corresponding to the shutters that can be opened and that are less subject to the solar radiation. The winter inner surface situation of the door is more stable due to the smaller RH% and T variations. During the summer the outside average temperatures range from 30,3 to 45,6 °C: these high values are worrying for the preservation of the door (fig. 3). On the contrary, the inner situation is more stable with temperature values ranging from 25,6 to 27,5 °C.

Figure 2 Average winter outdoor temperatures (°C)

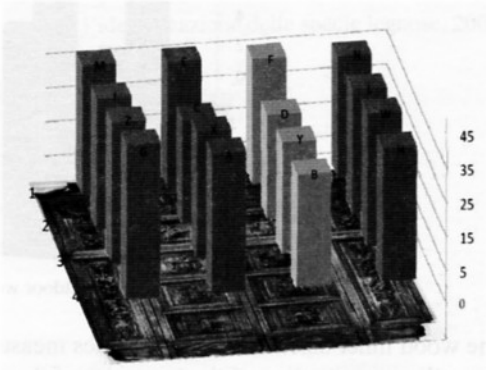
Figure 3 Average summer outdoor temperatures (°C)
